# Kembla Grange Recycling Pty Ltd

**RE: Part C Condition C9 SSD 5300 in relation to  
50 Wyllie Road Kembla Grange.**

## KGRPPL Response

APPENDIX A

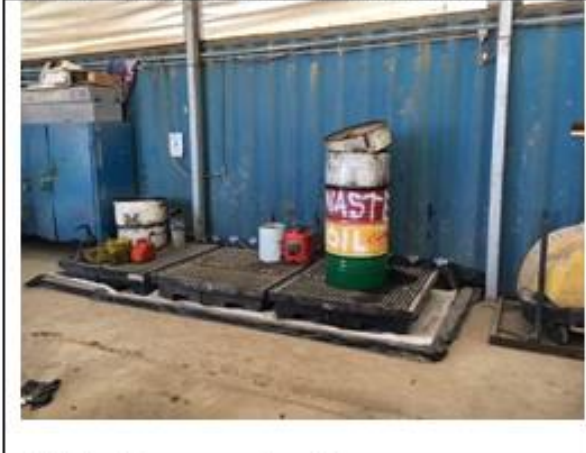
<p>NOC 7 – Erosion and sediment control</p>	<p>NOC 8 – Chemical storage area</p>

Non-compliance	Details	Recommended action	KGRPL Response
	<p>maintenance of sediment traps at perimeter fencing.</p> <p>Rumble grid is in poor condition and allowing sediment to track onto sealed road at exit.</p>		
<b>NOC 08 – Bunding</b>			
<p>B9 (SSD5300) requires that all chemicals, fuels and oils used on-site are stored in appropriately bunded areas in accordance with EPA standards.</p> <p>SWMP and SOPs (OPL-SEQ013 Storing Dangerous Goods, OPL-SEQ016 Labelling Hazardous Chemicals, OPL-YA029 Storage of Hazardous Chemicals – Waste) also have similar requirements.</p>	<p>Bunding and spill control in permanent chemical, fuel and oil storage areas not in accordance with SOPs and best practice.</p> <p>Mobile crate bunds are used instead of fixed bunds in permanent storage areas.</p> <p>Some sumps are clogged and not adequately cleaned at the time of audit.</p> <p>Signs of oil/fuel spills outside of the workshop bunded and storage areas.</p> <p>The main fuel storage tank not adequately bunded and covered and temporary fuel storage in fuel tank on crated bund in shed</p>	<p>Construct concrete bunding on the outside perimeter of the main permanent oil, fuel and chemical storage areas.</p> <p>Construct concrete bunds on the perimeter of the main fuel storage tank and generator storage sheds to contain any accidental spills during filling of fuel.</p> <p>Fixed cover should be installed over main fuel storage tank and filling areas.</p> <p>More regular inspections, maintenance and cleaning of workshop bunds, and sumps and ensure all work associated with chemicals, fuels and oils is conducted in designated covered and bunded areas.</p>	<p>Additional temporary bunding was provided to chemical storage areas prior to completion of the audit.</p> <p>Corrective actions for the workshop have been identified and are in progress. Actions have been completed for the following:</p> <ul style="list-style-type: none"> <li>• Waste oil storage cleaned and cleared</li> <li>• Temporary storage area expanded pending procurement of additional bunded storage.</li> <li>• The generator and associated shed were decommissioned and removed from site prior to completion of the audit.</li> <li>• There is one blind sump in the workshop which was cleared and cleaned prior to completion of the audit.</li> <li>• Temporary fuel storage remains undercover and on a crated bund pending review of fuel storage requirements.</li> <li>• The self-bunded double walled diesel tank is located adjacent to the workshop and</li> </ul>

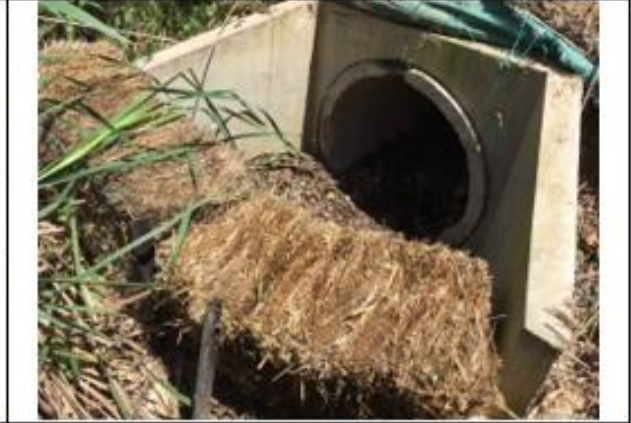
<p>NOC 8 – Temporary bunding</p>	<p>NOC 9 – Access tracks – traffic plan t weighbridge</p>

Non-compliance	Details	Recommended action	KGRPL Response
	<p>should be stored in properly designated fuel storage area.</p>		<p>requirements associated with covering this area are being reviewed.</p> <ul style="list-style-type: none"> <li>It is noted that it is not possible to conduct all work associated with chemicals fuels and oils in designated covered and bunded areas particularly in relation to mobile and fixed equipment breakdown. Procedures in relation to this type of servicing and maintenance will be reviewed.</li> </ul>
<b>NOC 09 – Access tracks</b>			
<p>s5 of the SWMP requires that access tracks are delineated, and sign posted.</p>	<p>Not all temporary access roads to undesignated areas were sufficiently delineated and sign posted.</p> <p>Access tracks behind ACM and mixed waste stockpiles behind concrete crushing area and mobile picking plant storage area are not clearly delineated and sign posted.</p> <p>Access tracks to the bin storage area and overflow car park clearly sign posted.</p>	<p>Provide proper delineation and sign posting of all access tracks, including temporary access tracks to undesignated areas.</p>	<p>The site traffic management plan is located at the inbound weighbridge window and traffic control staff manage access to all areas of site by two-way radio communication with vehicles. No vehicle is permitted to proceed without confirmation from site staff at each stage of the process. No vehicle is free to move around the site without two-way radio and communication with site staff. This requirement is covered in the site induction required of all customers and visitors to site.</p> <p>A site safety map / traffic plan is also located on the website <a href="#">Kembla Grange Site Safety Map</a>.</p> <p>A site plan in the form of a safety sign will be developed like the site traffic plan and posted adjacent to the rumble grid.</p>

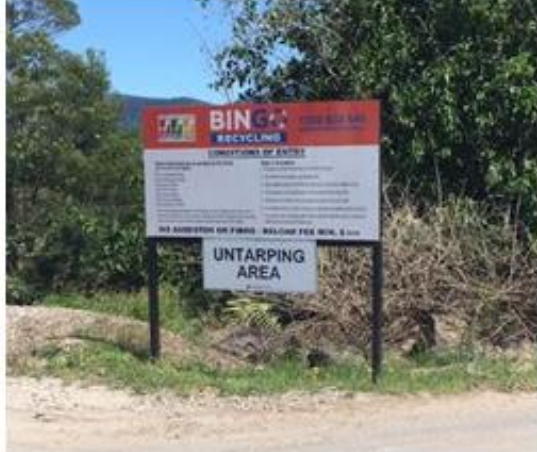
<p>NOC 10 – Generator and shed decommissioned and removed</p>	<p>NOC 12 – Clearance and screening of outlet</p>

Non-compliance	Details	Recommended action	KGRPL Response
<b>NOC 10 – Refueling</b>			
s4(m) SWMP - no refueling within 30m of the riparian corridor.	Diesel generator in container/shed within 2 m of riparian zone and evidence of refueling activities including open fuel cans and spillage inside and outside of container close to drain/grate pit.	Relocate diesel generator away from riparian zone and place in a specially designated area that is properly designed, lit, ventilated, bunded, and has the required fire-fighting controls / equipment.	Refer to response at NOC 08  The generator and associated shed were decommissioned and removed from site prior to completion of the audit.
<b>NOC 11 – Groundwater monitoring</b>			
s14(b) SWMP requires copies of results of groundwater monitoring to be provided to Office of Water.	No record of copies of the groundwater monitoring results being provided to the Office of Water.	Provide all copies of groundwater monitoring results to the Office of Water.	The KGRPL will seek a report concerning groundwater monitoring and incorporating groundwater monitoring results from the consultant and provide the report to the Office of Water.

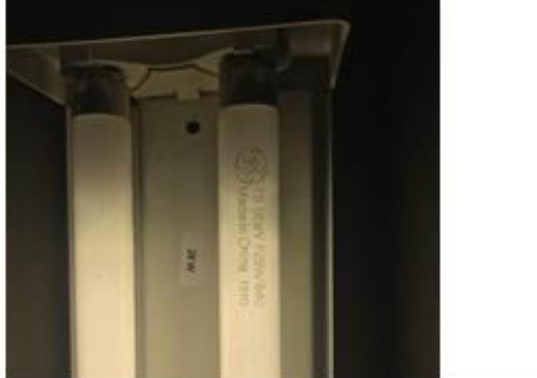
Descriptions	Value	Wattage	28	Base	Tube	Life (Hrs)	30000	Lumens	2640	Diameter	16mm	Length	1149mm	Colour Rendering Index Ra	85	Colour Temperature	4000	Manufacturers Part Number	61102	Supplier Number	61102	Lumens per Watt	94.3	Energy efficacy rating	★★★★
Descriptions	Value																										
Wattage	28																										
Base	Tube																										
Life (Hrs)	30000																										
Lumens	2640																										
Diameter	16mm																										
Length	1149mm																										
Colour Rendering Index Ra	85																										
Colour Temperature	4000																										
Manufacturers Part Number	61102																										
Supplier Number	61102																										
Lumens per Watt	94.3																										
Energy efficacy rating	★★★★																										
<p>NOC 09 - Site traffic plan</p>	<p>NOC 23 – Lighting 4 star energy rating</p>

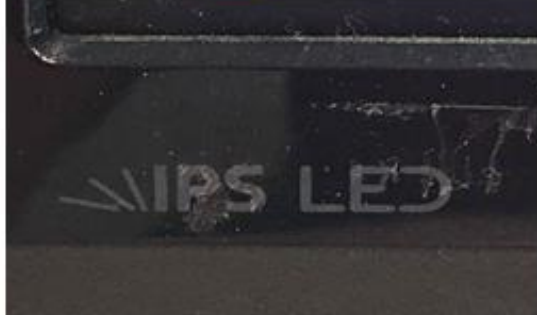
<p>NOC 23 - Lighting 4 star energy rating</p>	<p>NOC 23 - Computer monitors energy star rated</p>

s4.10 (iv-vi) of RSOC requires energy metering, monitoring and efficient lighting / appliances.	No evidence of Facility energy efficiency monitoring and installation of efficient lighting / appliances.	Put in place an energy efficiency plan, monitoring program and install efficient lighting / equipment & appliances.	Energy efficient lighting was installed in the weighbridge, lunchroom and externally to buildings. The workshop lighting is LED. Refrigerators are 3.5 star. The site is not connected to mains power and therefore not metered to the grid however it does monitor energy use in relation the generator on site. Refer to Appendix A
